HOW CONFIDENT ARE YOU ABOUT YOUR CONNECTOR CLEANLINESS?

Vincent Racine, Product Line Manager, Francis Audet, Advisor, CTO Office, François Marcotte, Senior Technical Sales Specialist
Gwennaél Amice, Senior Application Engineer

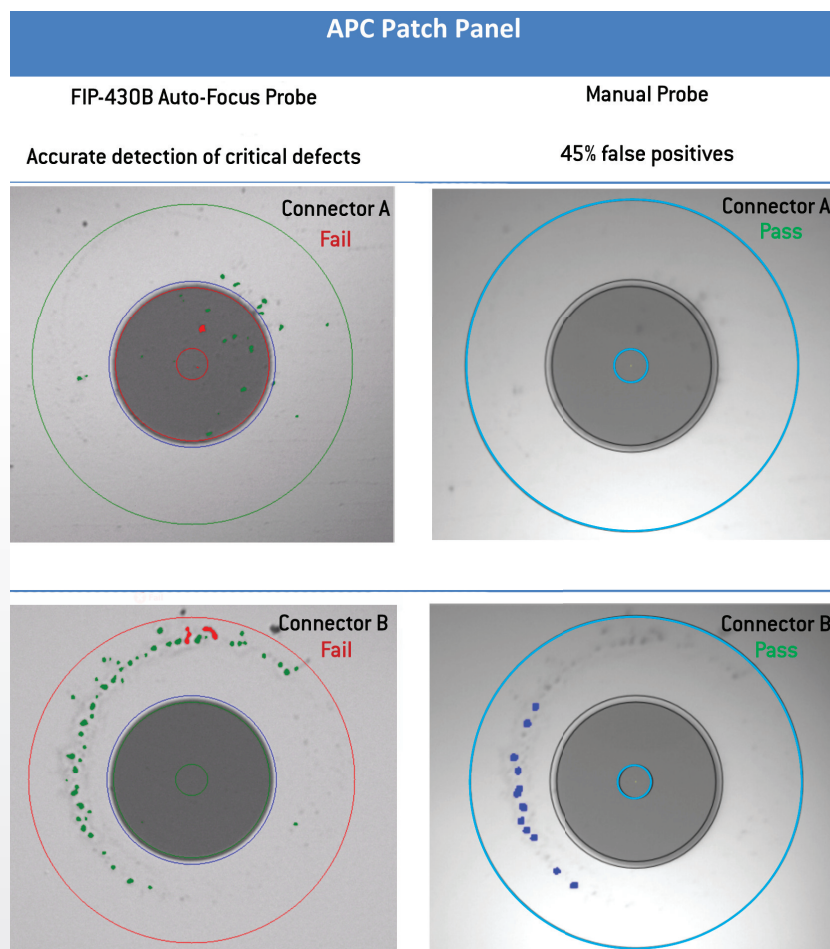
The following images compare manual centering and focusing to automatic centering and focusing. The methodology involved inspecting the connector, cleaning it and inspecting it again (with the manual focus probe) until a pass was obtained. The same port was then inspected with an automated unit.

Figure 1. Manual versus automatic focusing

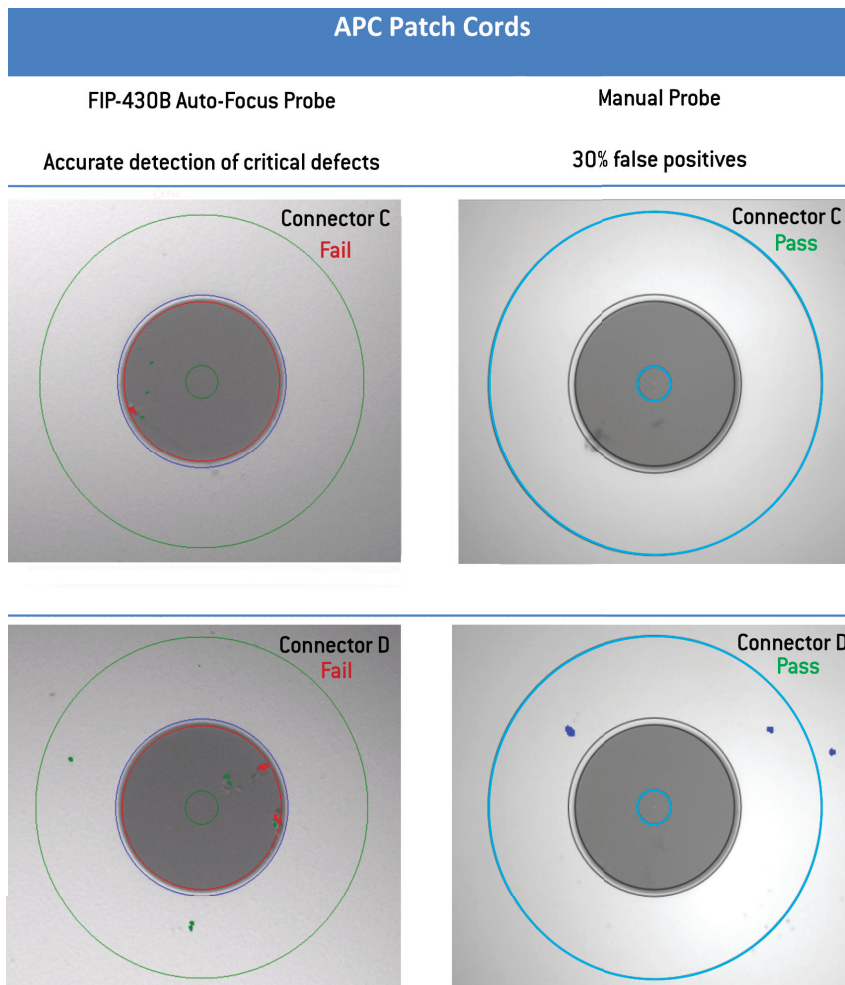
Figure 2. Manual versus automatic focusing

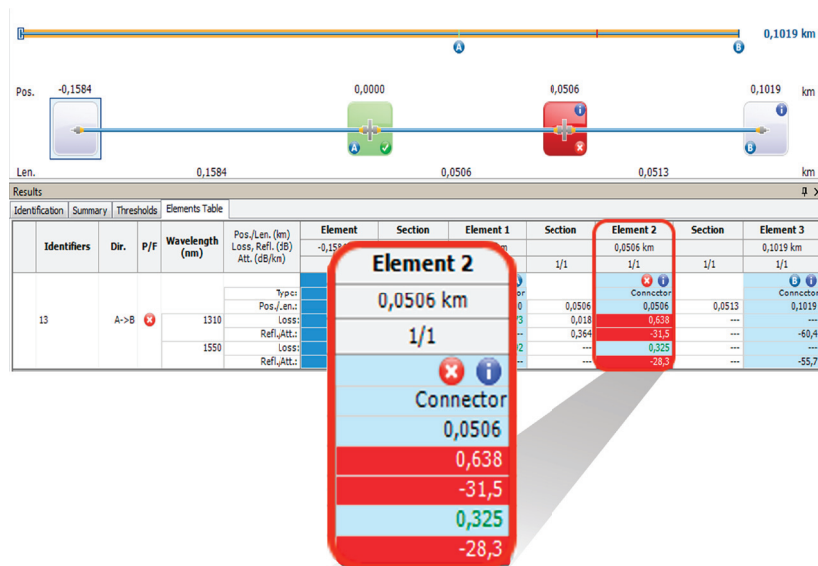
Since a dirty connector will typically exhibit more reflectance and loss, the optical return loss (ORL) and IL readings taken by an OTDR will be higher. The image below illustrates this common problem. The experiment was conducted on a very short, 101.4-meter singlemode fiber link. Fiber loss in itself accounts for approximately 0.003 dB at 1310 nm, which is deemed inconsequential. The ORL and IL reading at 1310 nm for connector 2 is 0.638 dB, with a reflection of -31.5 dB. The link ORL is 27.86 dB.

Figure 5. ORL and IL readings on an uncleaned connector

If we apply these results to the datacenter example above, only three of these bad connections would have failed at 40G data rates and higher.

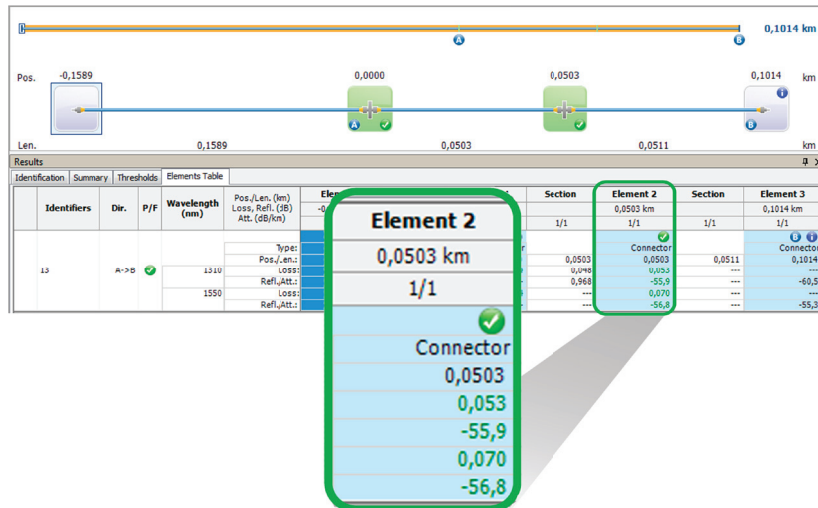
After cleaning the connectors, the loss reading dropped to 0.053 dB at 1310 nm, with a reflectance of -55.9 dB. The link ORL also dropped to 50.4 dB. Everything is back to normal.

Figure 6. ORL and IL readings on a cleaned connector

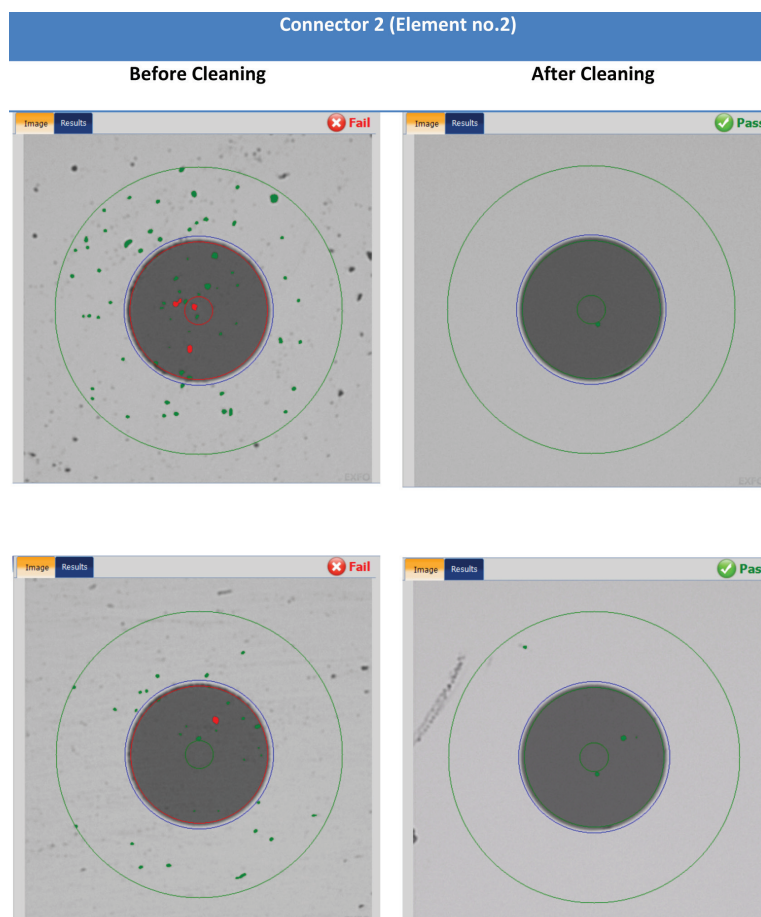
The image below shows connector 2 before and after cleaning. It is interesting to note that the contaminant here is not grease or oil from the technician's fingers, but simply dust collected from the environment (e.g., drywall, concrete, skin particles and sand). Therefore, even when a technician does not touch the connector endface, it can still be contaminated.

Figure 7. Connector 2 before and after cleaning
